CEDD SERVICE CONTRACT NO. EDO 12/2023
ENVIRONMENTAL TEAM FOR DEVELOPMENT OF
ANDERSON ROAD QUARRY SITE – SITE FORMATION
AND ASSOCIATED INFRASTRUCTURE WORKS

MONTHLY ENVIRONMENTAL MONITORING AND AUDIT
REPORT (OCTOBER 2024)

PREPARED FOR
CIVIL ENGINEERING AND DEVELOPMENT DEPARTMENT
(CEDD)

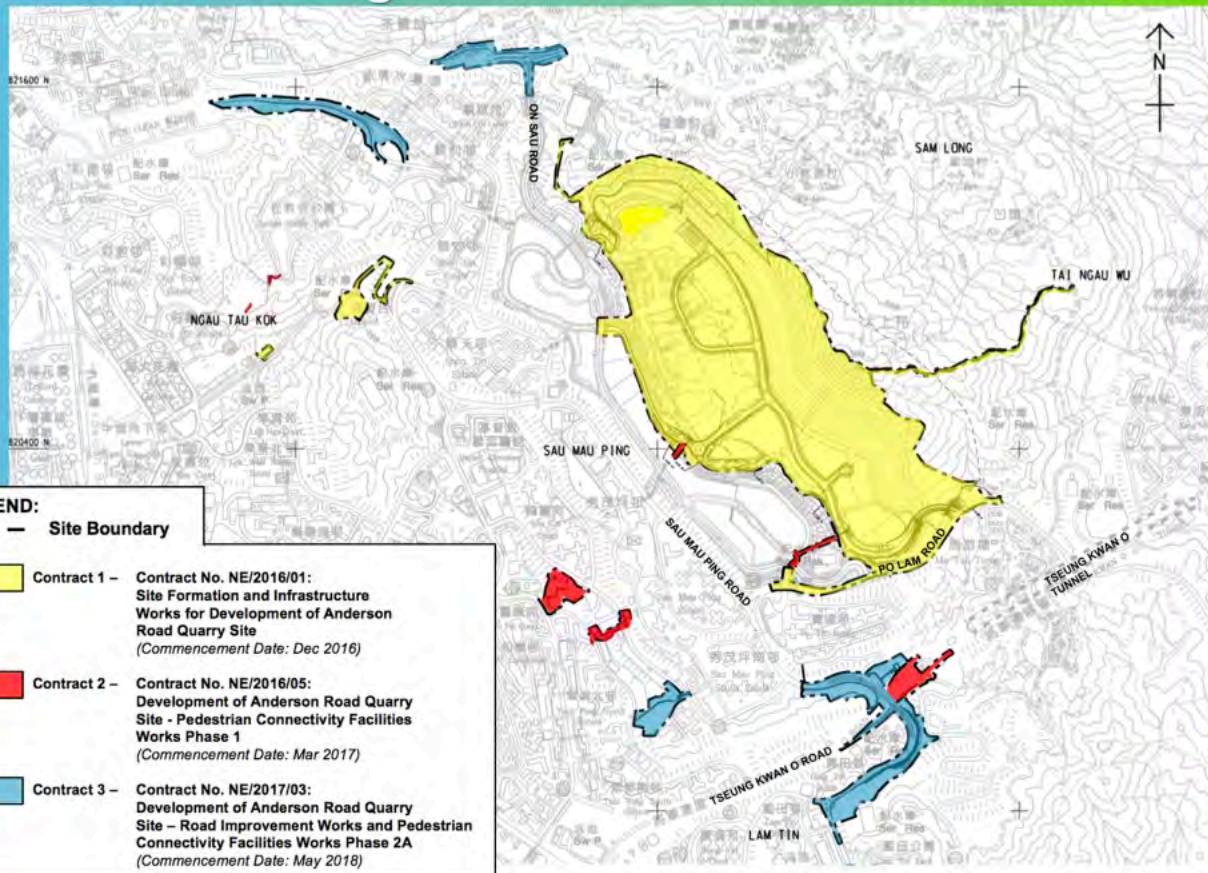
Layout plan of the Project

Contract Packages

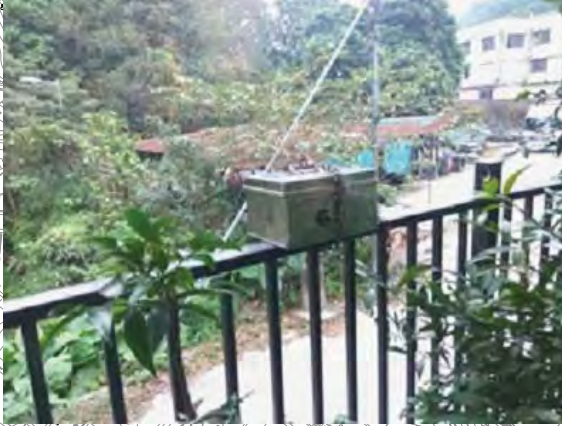
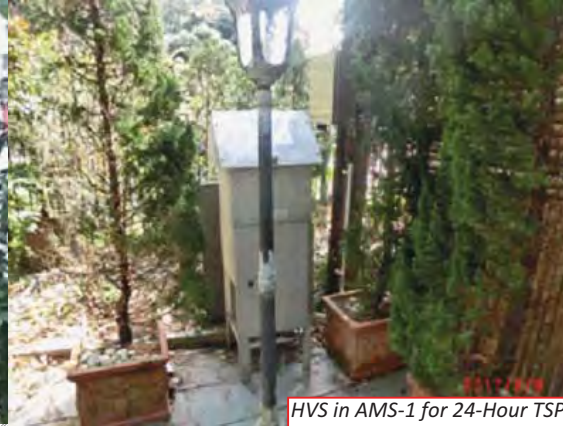
HVS in AMS-1 for 24-Hour TSP

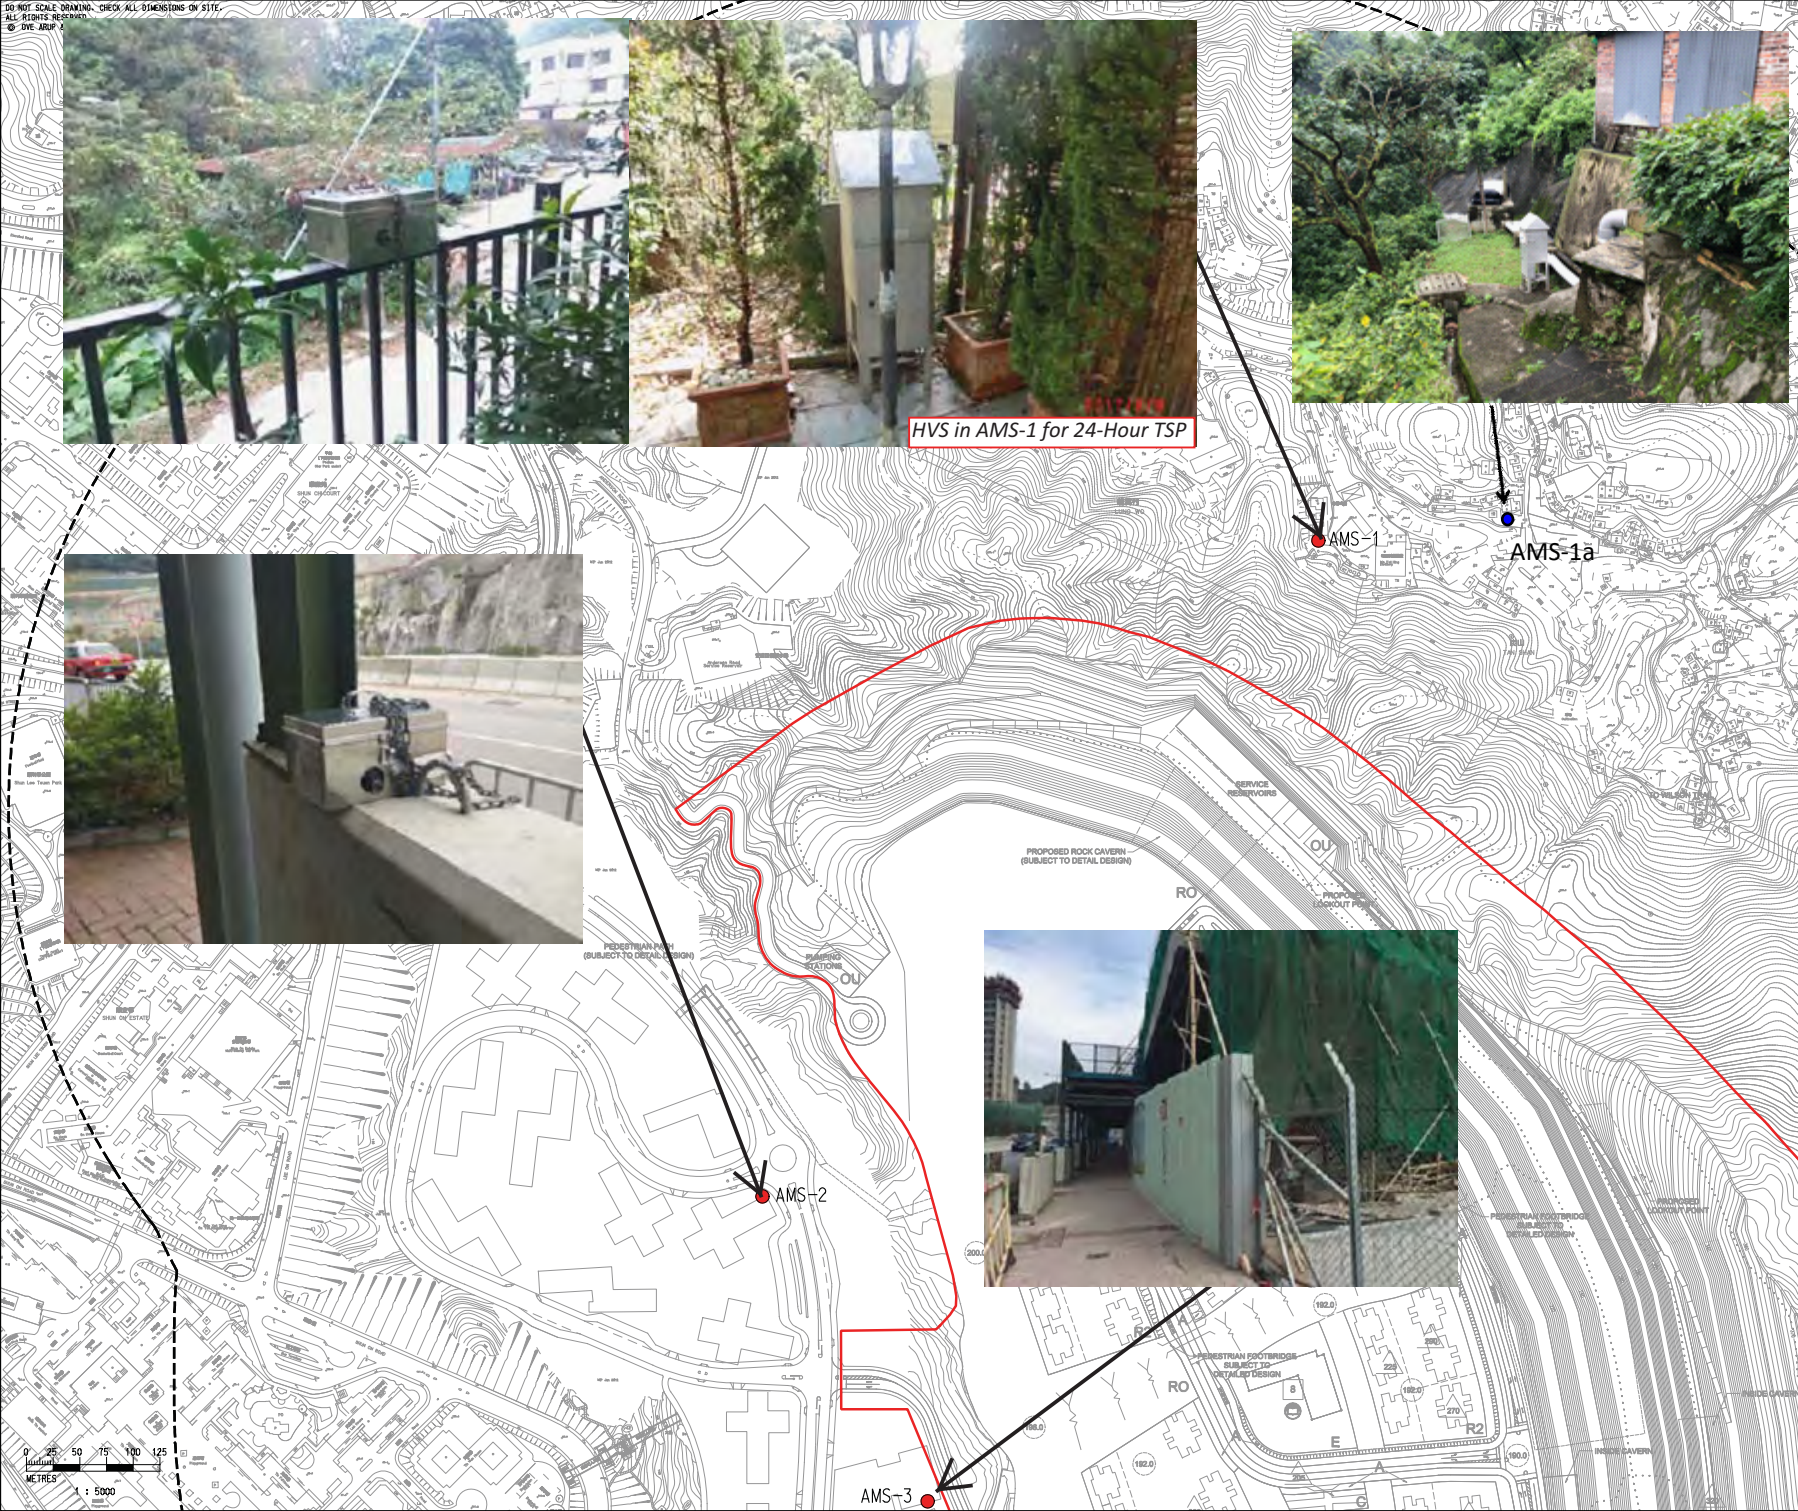
Printed by : 4/8/2014
Filename : G:\env\project\227724-50\13 Drawing Deliverables\08 EM&A\02 Revised draft\Ar 227724_E_0045_B - Locations of Construction Dust Monitoring (Sheet 1 of 3).dgn

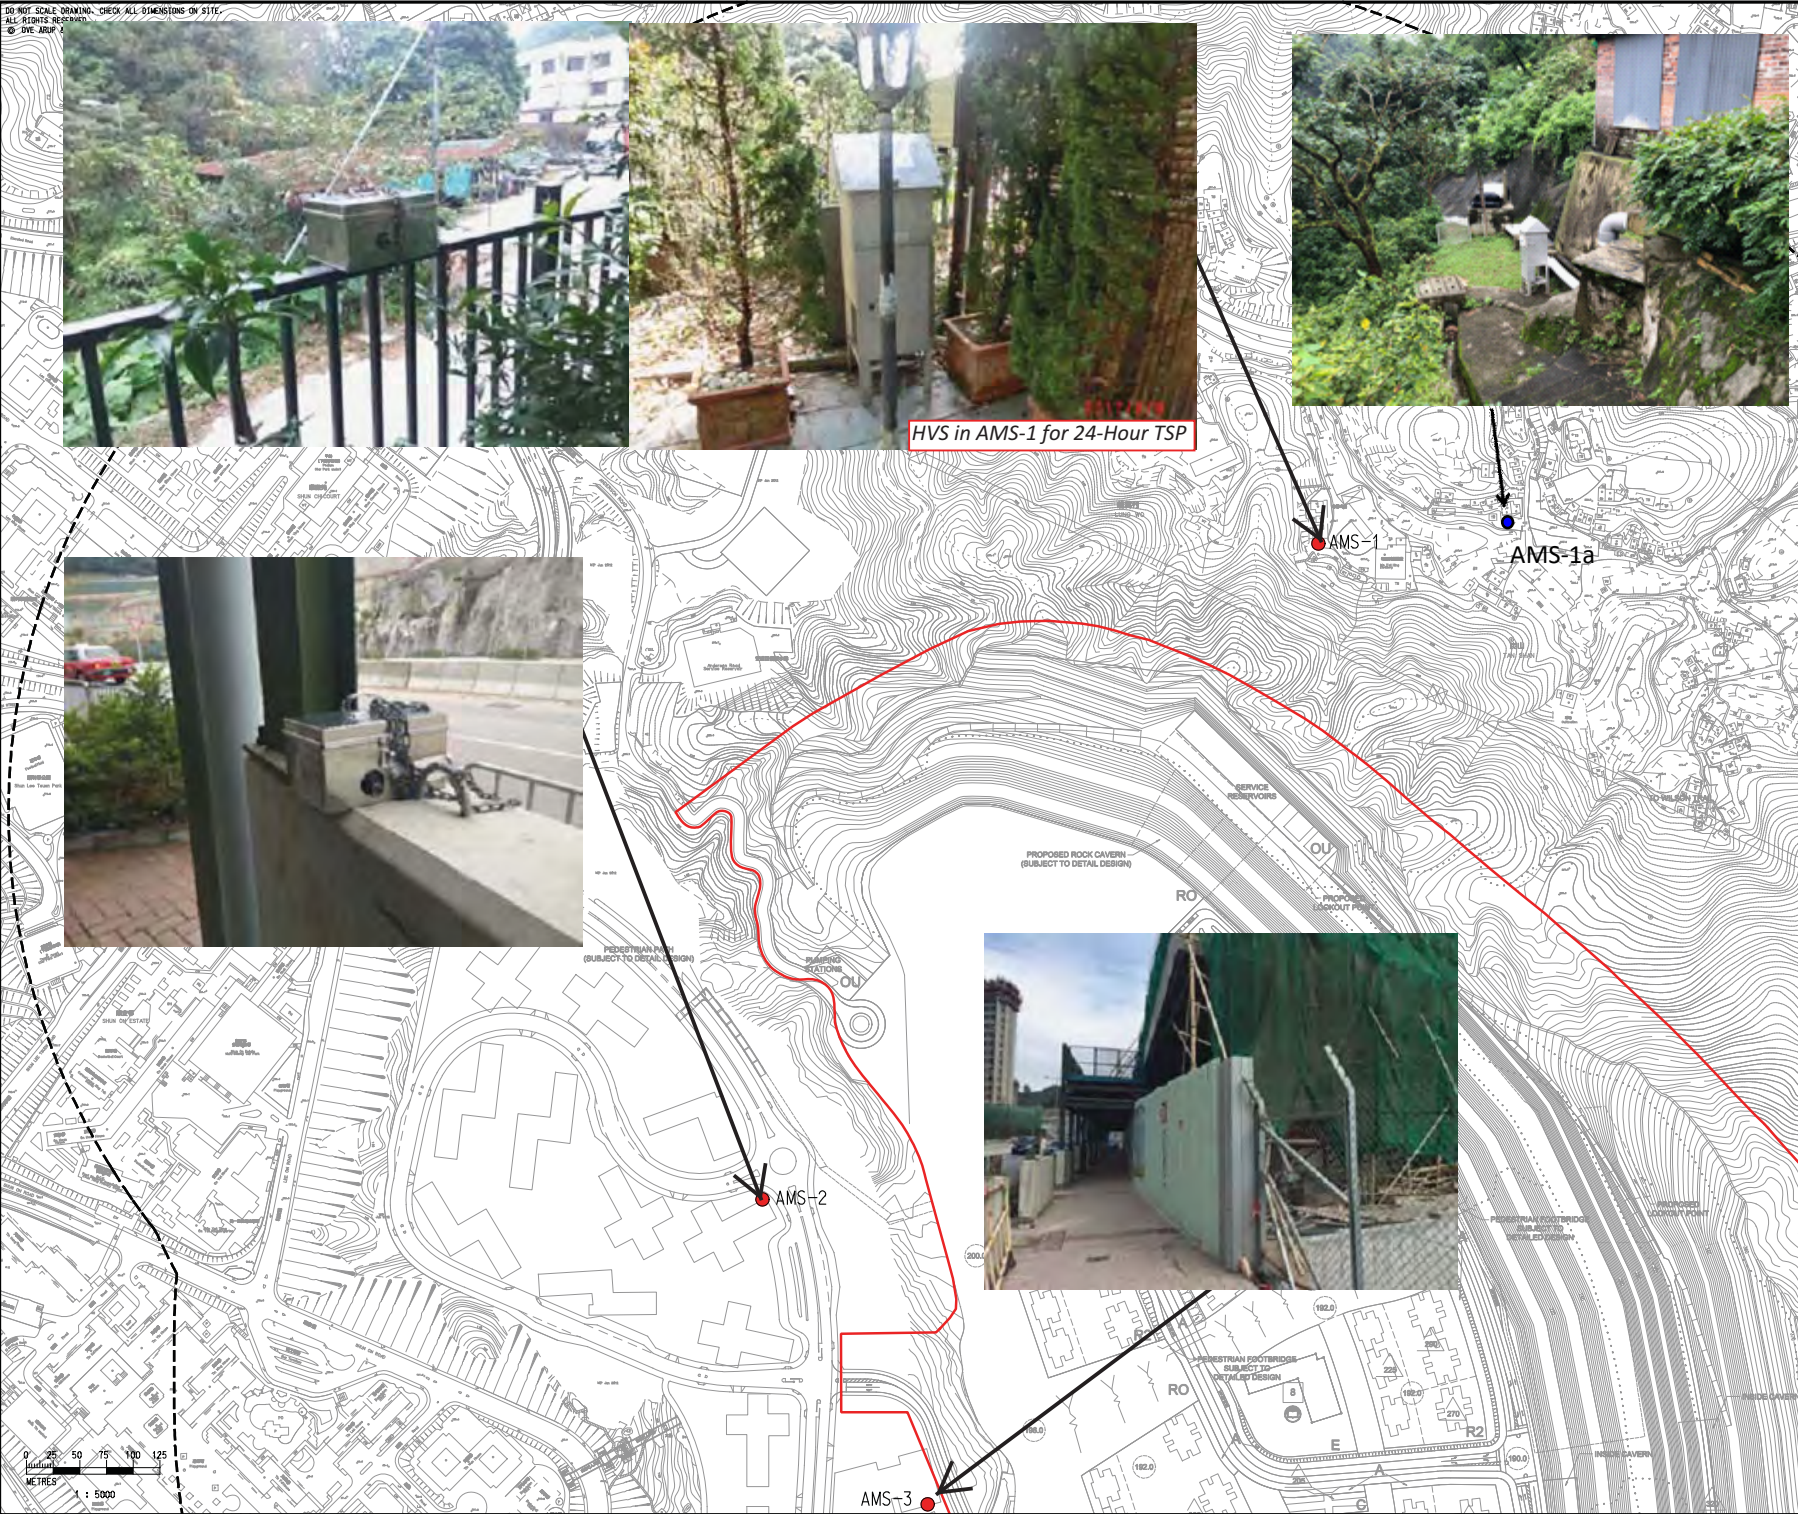
B SECOND ISSUE	GL 03/14
A FIRST ISSUE	GL 10/13
Rev Description	By Date
ARUP	
Contract No. and Title	
Agreement No. CE 18/2012(CE)	
Development of Anderson Road Quarry - Investigation	
Drawing title	
Locations of Construction Dust Monitoring (Sheet 1 of 3)	
Drawing no. 227724/E/1045	Rev. B
Drawn GL Date 03/14	Checked TC Approved ST
Scale 1:5000 @A3	Status PRELIMINARY
COPYRIGHT RESERVED	
	土木工程拓展署 Civil Engineering and Development Department

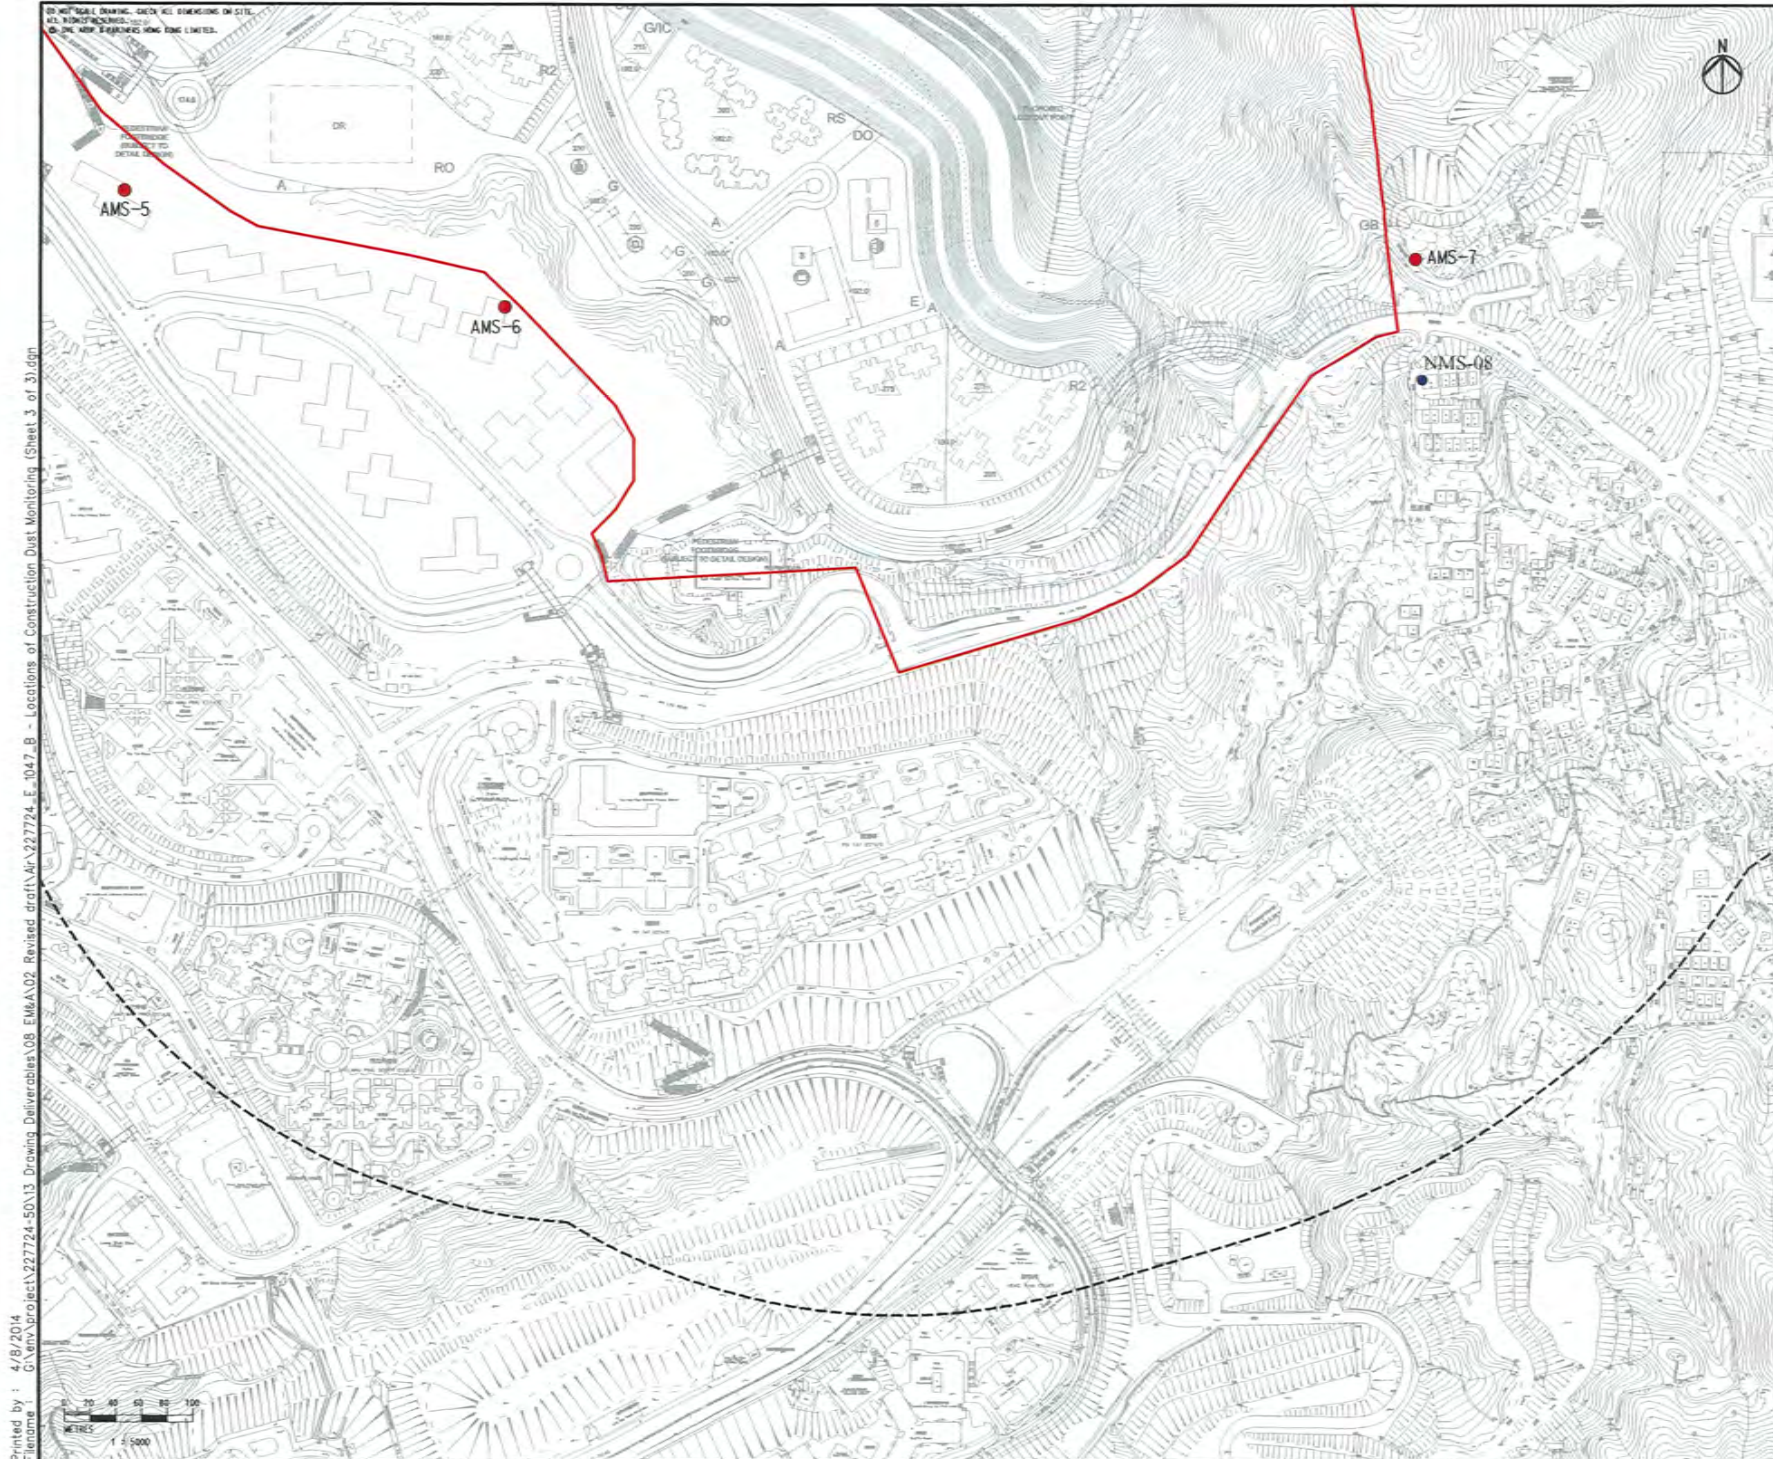
Printed by : 6/3/2014
 Filename : \\HKGNIS22\acoustic\env\project\227724-50\13 Drawing Deliverables\08 EIM&A\03 Final Noise\227724_E-2400_C - Locations of Noise Monitoring.dgn

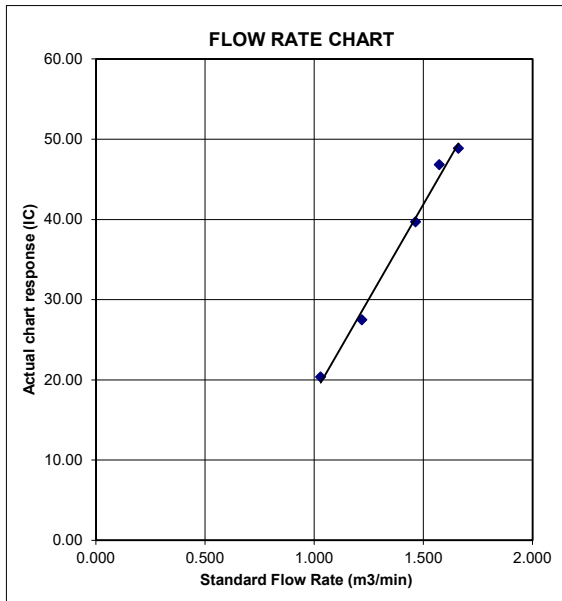
Location : Oi Tat House	Date of Calibration: 28-Aug-24
Location ID : AMS 5	Next Calibration Date: 28-Oct-24
Model: TISCH High Volume Air Sampler TE-5170	Technician: Martin

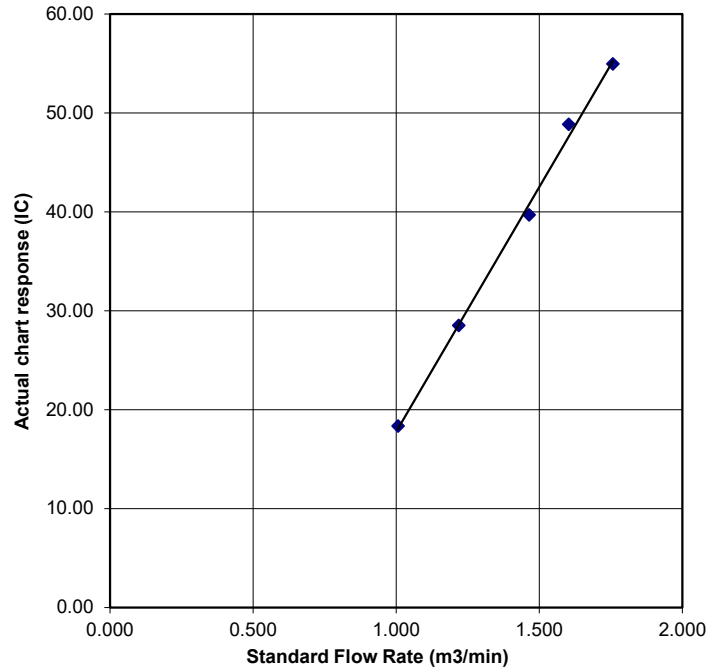
FLOW RATE CHART

Location : Hau Tat House	Date of Calibration: 28-Aug-24
Location ID : AMS 6	Next Calibration Date: 28-Oct-24
Model: TISCH High Volume Air Sampler TE-5170	Technician: Martin

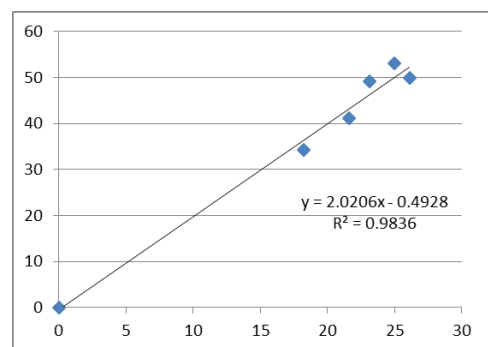
- Strong** Correlation (R>0.8)
- Factor 2.0206 (ug/m³)/CPM should be apply for TSP monitoring

*If R<0.5, repair or re-verification is required for the equipment

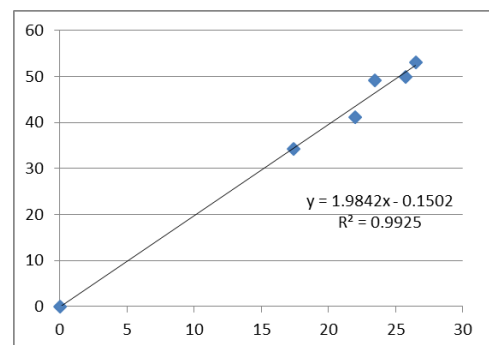
Correlation Coefficient (R) 0.9962

- Strong** Correlation ($R > 0.8$)
- Factor 1.9842 (µg/m³)/CPM should be apply for TSP monitoring

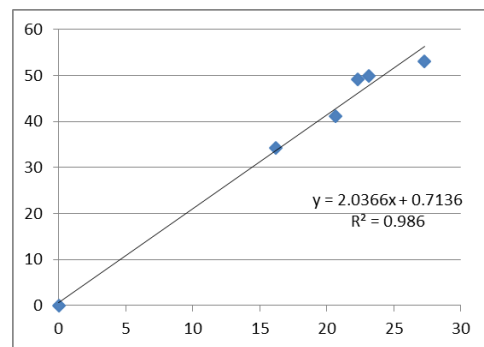
- Strong** Correlation (R>0.8)
- Factor 2.0366 (µg/m³)/CPM should be apply for TSP monitoring

*If R<0.5, repair or re-verification is required for the equipment

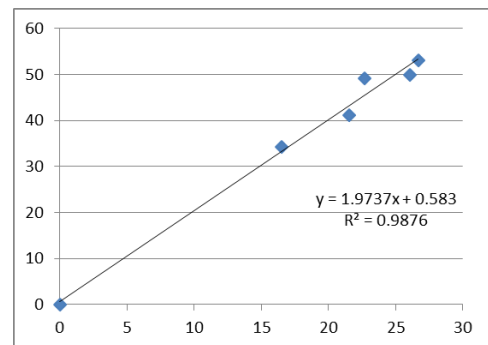
Correlation Coefficient (R) 0.9937

- Strong** Correlation ($R > 0.8$)
- Factor 1.9737 (µg/m³)/CPM should be apply for TSP monitoring

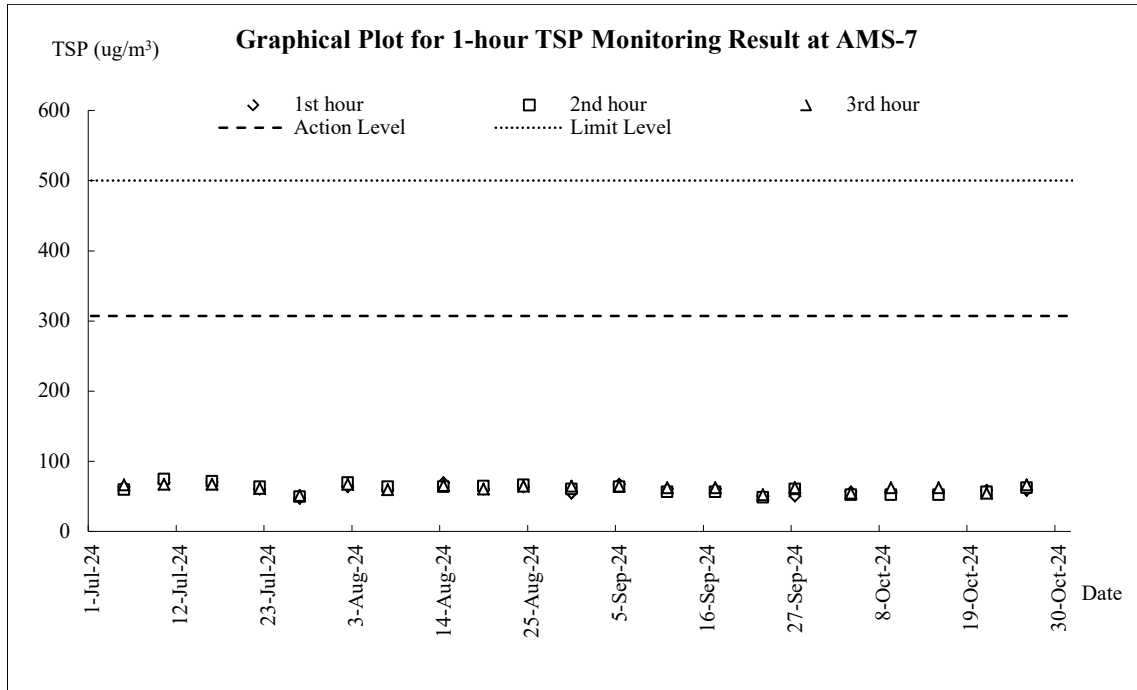
Air Quality – 24-hour TSP

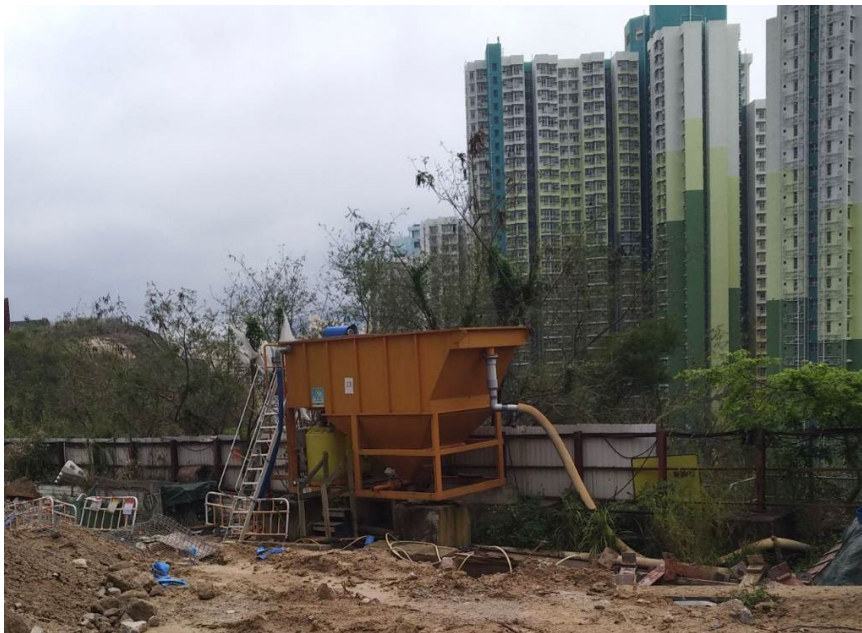
Q1. Wastewater treatment facility 30 cu.m Sedimentation Tank + AquaSed of 15 cu.m per hour + WETSEP
