**ENVIRONMENTAL TEAM FOR
DEVELOPMENT OF
ANDERSON ROAD QUARRY SITE -
ROAD IMPROVEMENT WORKS**

UNDER ENVIRONMENTAL PERMIT NO. EP-513/2016

MONTHLY ENVIRONMENTAL MONITORING & AUDIT REPORT

MARCH 2024

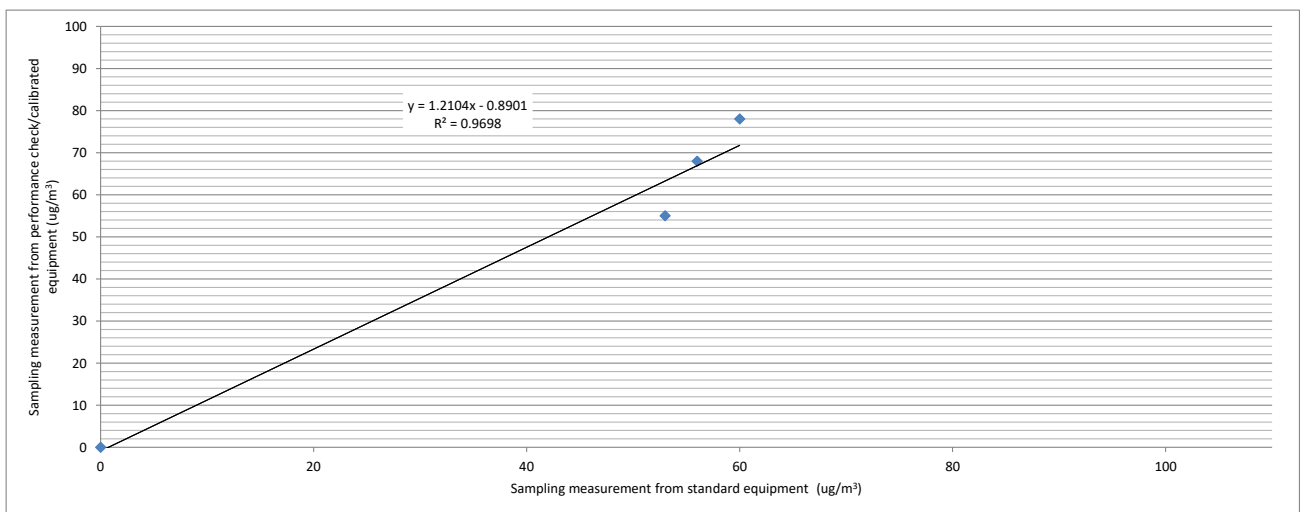
Linear Regression of Y on X

Slope (K- factor) : 1.3000
Correlation Coefficient : 0.9876
Validity of Performance Check / Calibration Record : 30/3/2023

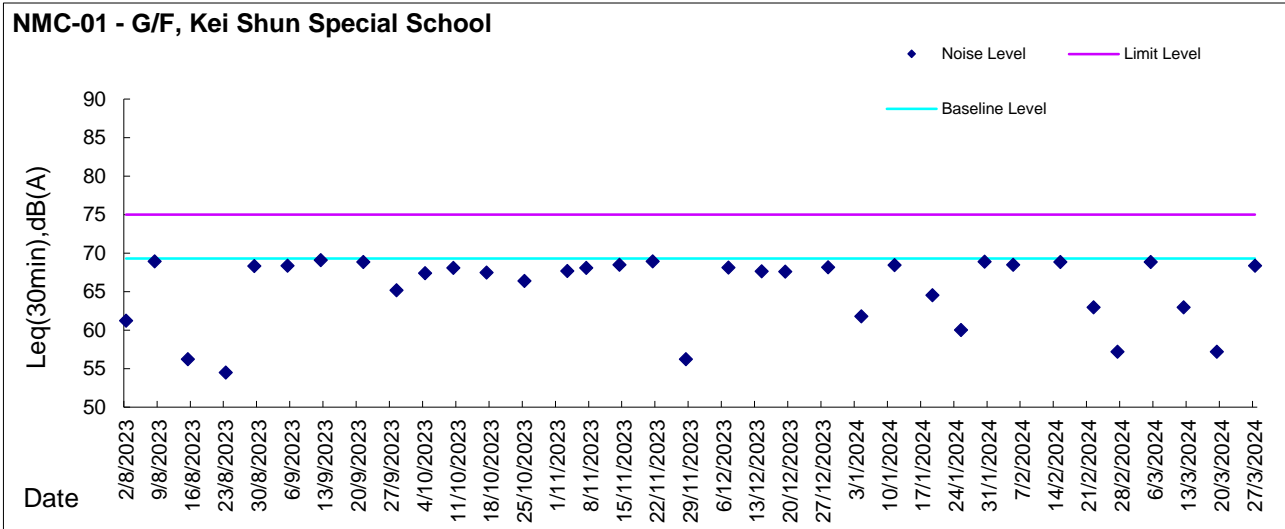
NMC-01 - G/F, Kei Shun Special School

Day Time (0700 - 1900hrs on normal weekdays)

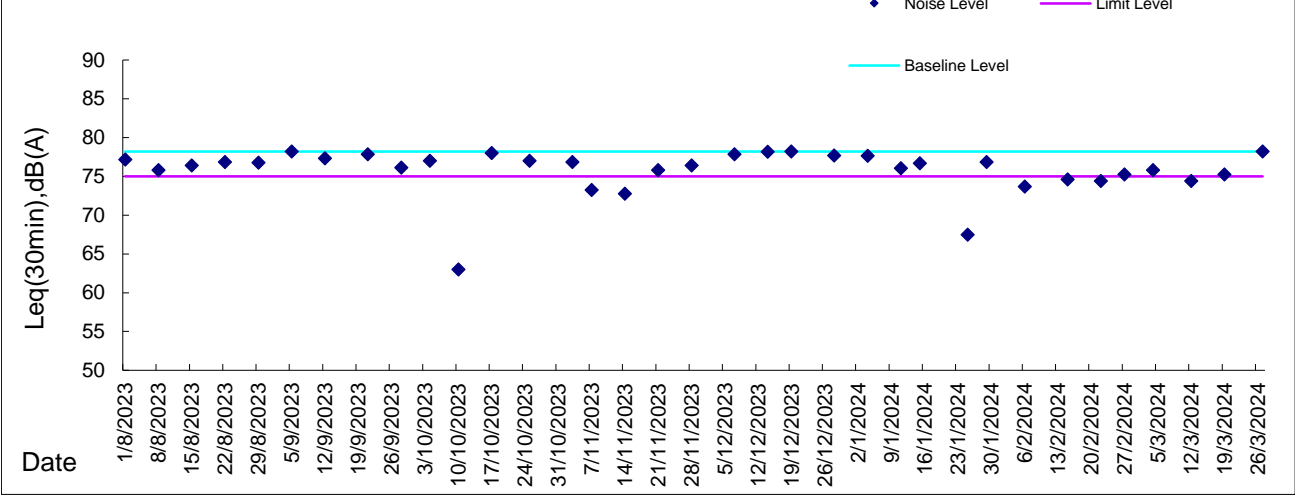
NMC-03 - G/F, Sienna Garden Block 6

Graphic Presentation of Noise Monitoring Result
Day Time (0700 - 1900hrs on normal weekdays)

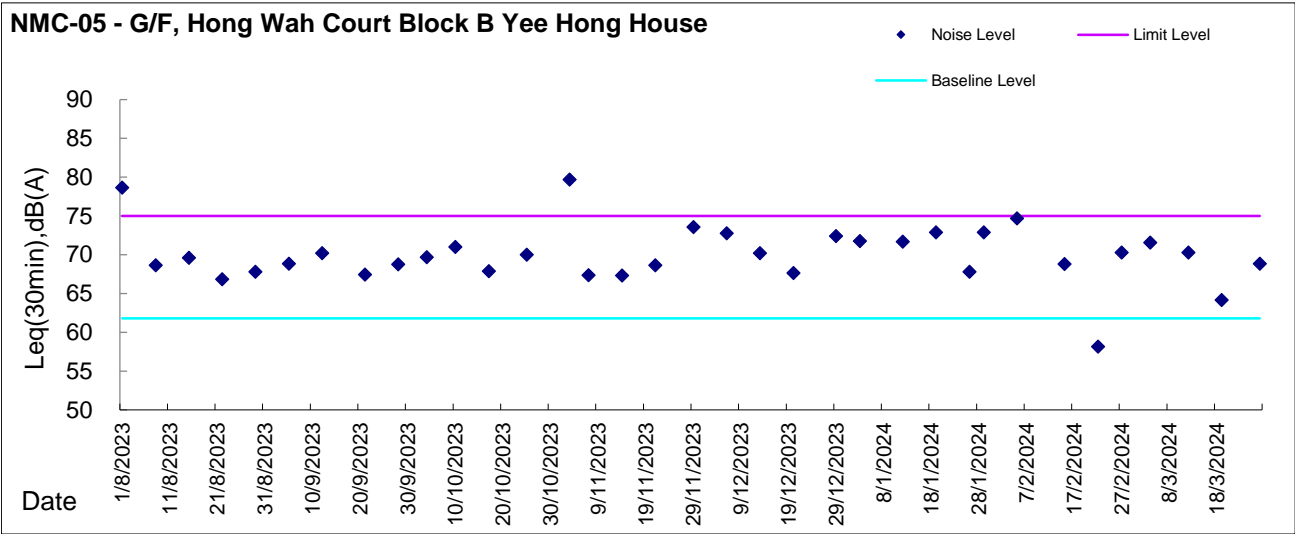
NMC-05 - G/F, Hong Wah Court Block B Yee Hong House

Graphic Presentation of Noise Monitoring Result

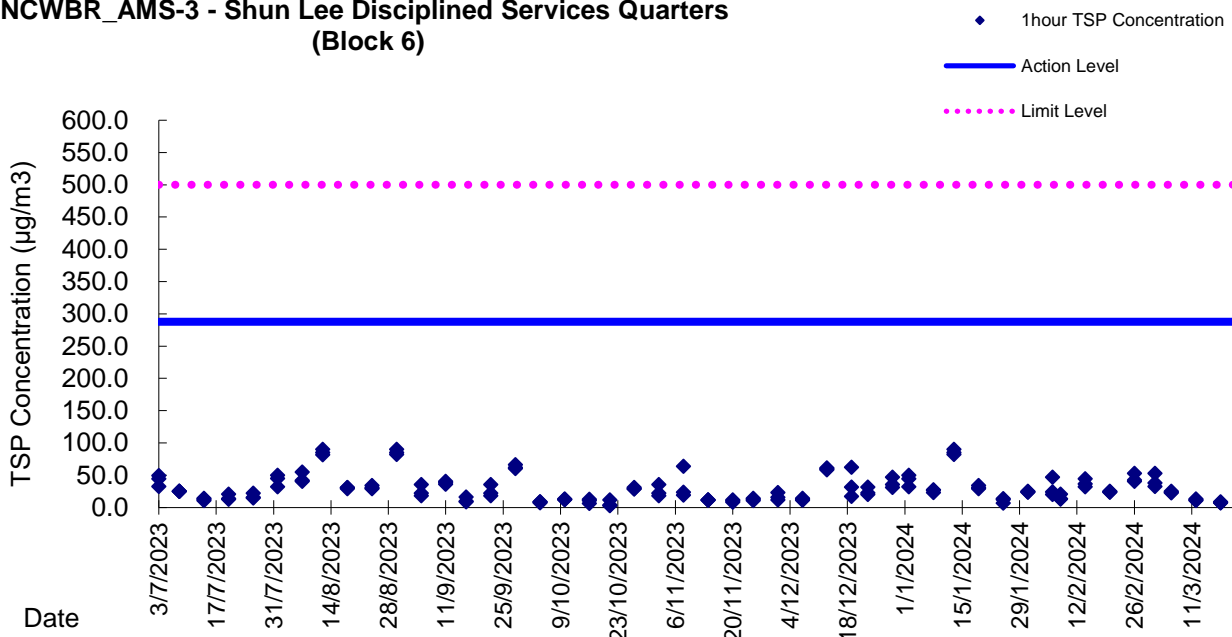
NCWBR_AMS-3 - Shun Lee Disciplined Services Quarters (Block 6)

Graphic Presentation of TSP Result
